JORDAN LAKE LAKE CLASSIFICATION REPORT

**Presented by Reesa Evans, CLM, Lake Specialist
Adams County Land & Water Conservation Department
P.O. Box 267, Friendship, WI 53934**

MARCH 2008

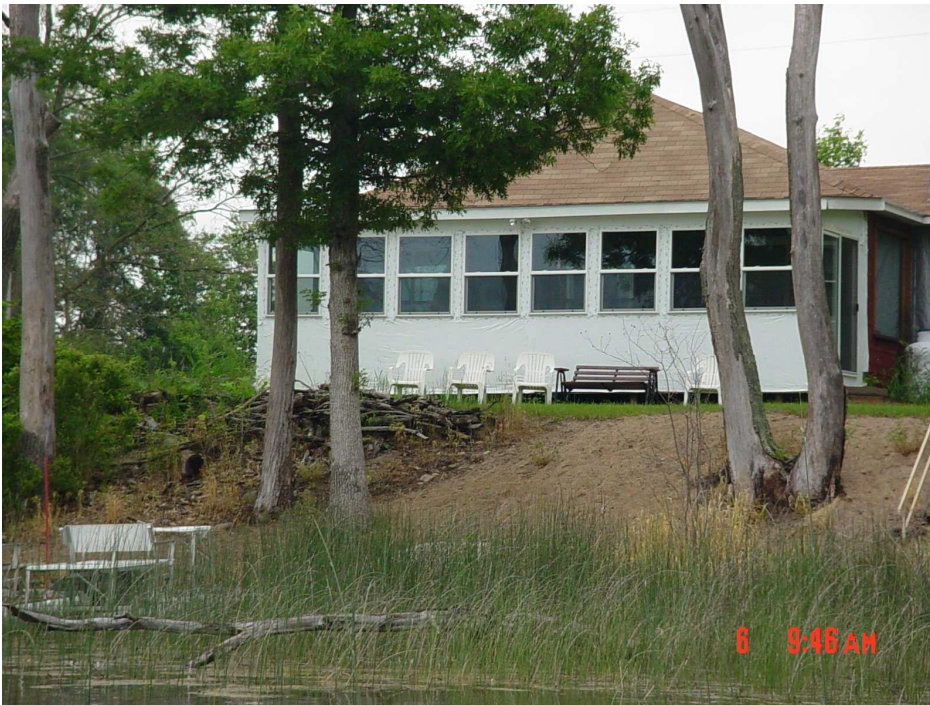
Figure 13: Example of Inadequate Buffer

When the natural shoreline is replaced by traditional mowed turf-grass lawns, rock, wooden walls or similar installments, bird and animal life, land-based insects, and aquatic insects that hatch or winter on natural shore are negatively impacted. For example, on many Adams County lakes, the non-native aquatic plant, Eurasian Watermilfoil has invaded. There is a weevil native to Wisconsin that weakens Eurasian Watermilfoil by burrowing into and developing within its stems, but that weevil depends on a native-plant shore to overwinter. If the shore is instead covered by rock, seawall or traditional lawn, these weevils will be unavailable for the lake to use as Eurasian Watermilfoil control.

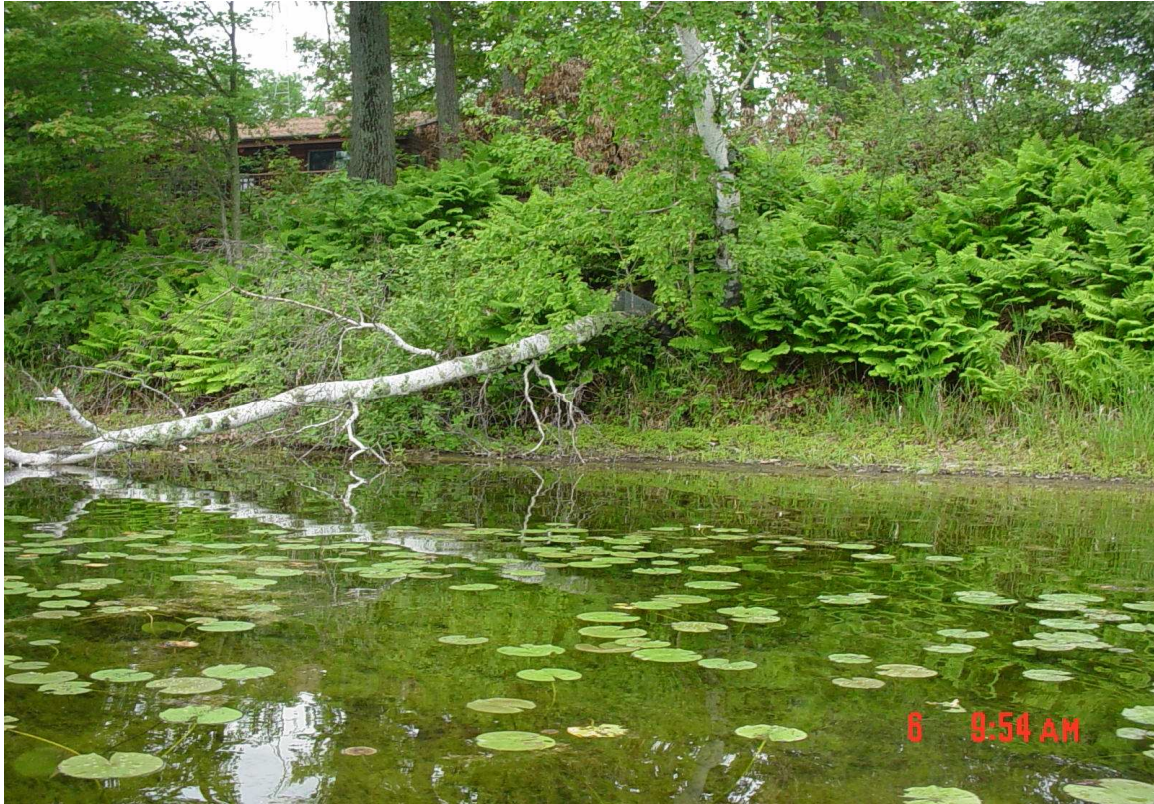
Figure 14: Example of Adequate Buffer

The filtering process and bank stabilization that buffers provide help improve a lake's water quality, including water clarity. Studies in Minnesota, Maine and Michigan have shown that waterfront property value increases for every foot the water clarity of a lake increases. (Krysel et al, 2003).

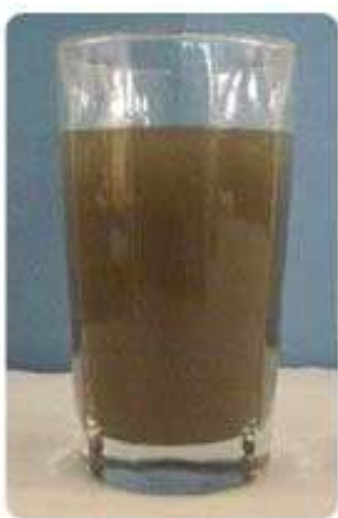
**Figure 35:
Examples
of Very
Turbid Water**

TURBIDITY: Turbidity reflects water clarity. The term refers to suspended solids in the water column—solids that may include clay, silt, sand, plankton, waste, sewage and other pollutants. Turbid water may mask the presence of bacteria or other pollutants because the water looks murky or muddy. In general, turbidity readings of less than 5 NTU are best. Very turbid waters may not only smell, but also tend to be aesthetically displeasing, thus curtailing recreational uses of the water. Turbidity levels for Jordan Lake's waters were 2.08 NTU in 1992; 2.03 NTU in 2004, 2.49 NTU in 2005, and 2.59 NTU in 2006—all low levels.

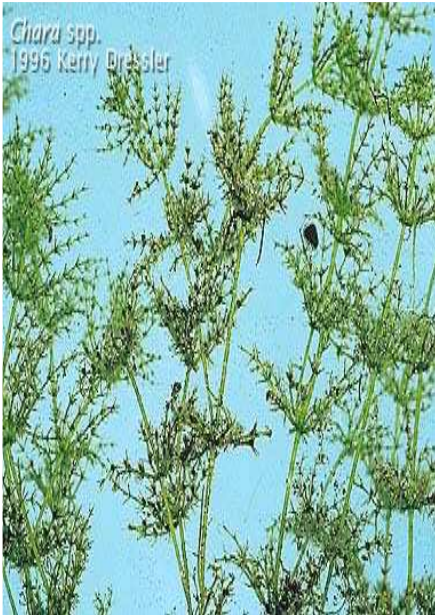
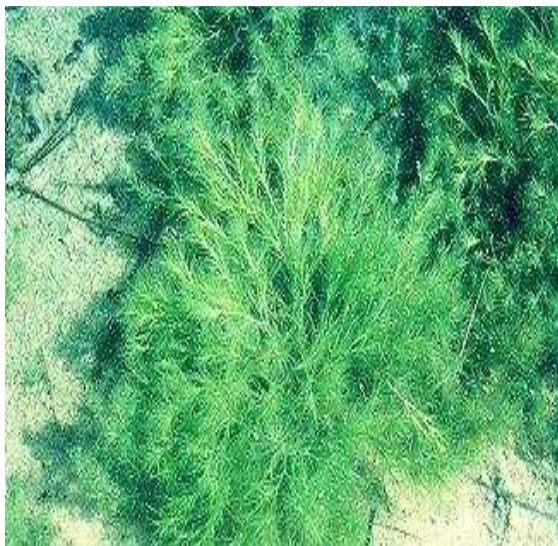
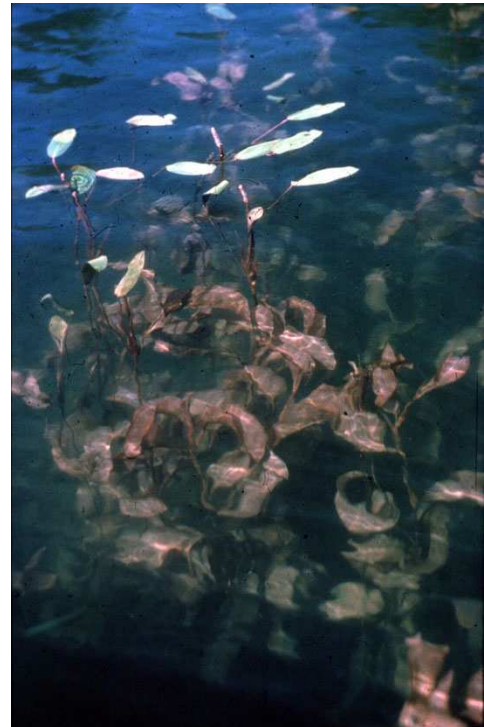
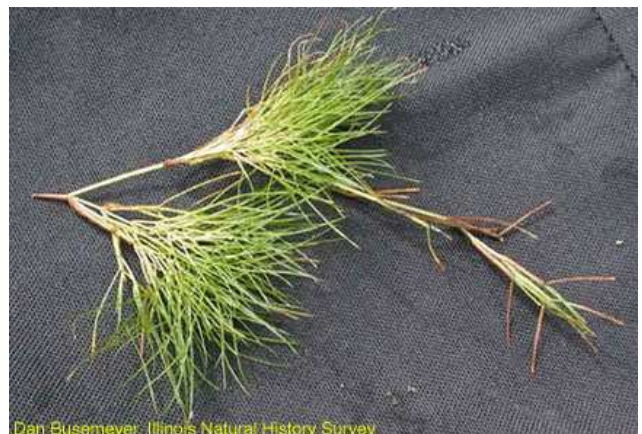
Figure 44:
Four Most
Common
Native
Aquatic
Species in
Jordan Lake

Chara spp (Muskgrass)

Najas flexilis
(Bushy Pondweed)

Potamogeton amplifolius
(Large-Leaf Pondweed)

Potamogeton pectinatus
(Sago Pondweed)

Chara spp (muskgrass), a plant-like algae, was the most common and most dense species found during the aquatic plant survey. Second in frequency was *Najas flexilis* (bushy pondweed). *Chara* spp was also the dominant species. *Najas flexilis* was sub-dominant. Three invasive aquatic plants were found: *Myriophyllum spicatum* (Eurasian watermilfoil, a submergent), *Phalaris arundinacea* (reed canarygrass, an emergent), and *Potamogeton crispus* (curly-leaf pondweed, a submergent). Of the invasives, Eurasian watermilfoil was the most commonly occurring species and was found in all four depth zones. The lake historically has used chemical spot treatments to manage the Eurasian watermilfoil. In addition, a survey in 2007 indicated that the native weevil, *Euhrychiopsis lecontei*, was present in parts of Jordan Lake. This weevil, if present in sufficient density, can weaken Eurasian milfoil plants to the point of death.

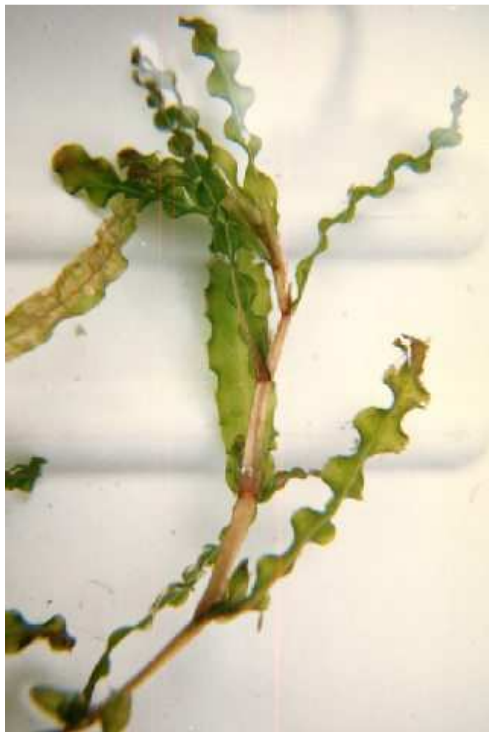
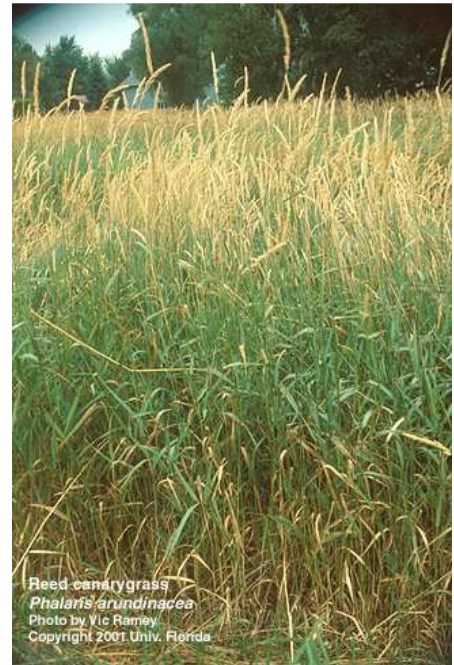
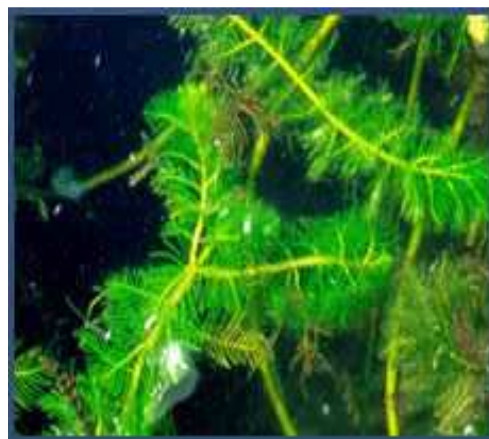
**Figure 46: Three Invasive
Aquatic Plants in Jordan Lake**

Curly-Leaf Pondweed was also found in Jordan Lake in 2006, but only at four sites in water 1.5 feet to 5 feet deep. Although it is present, it does not appear in either high frequency or density. Reed Canarygrass was also found on the shores of Jordan Lake in 2006 in three sites, but also did not appear in either high frequency or density. However, ongoing monitoring for both of these plants should occur.

Potamogeton crispus
(Curly-Leaf Pondweed)

Phalaris arundinacea
(Reed Canarygrass)

Myriophyllum spicatum
(Eurasian Watermilfoil)

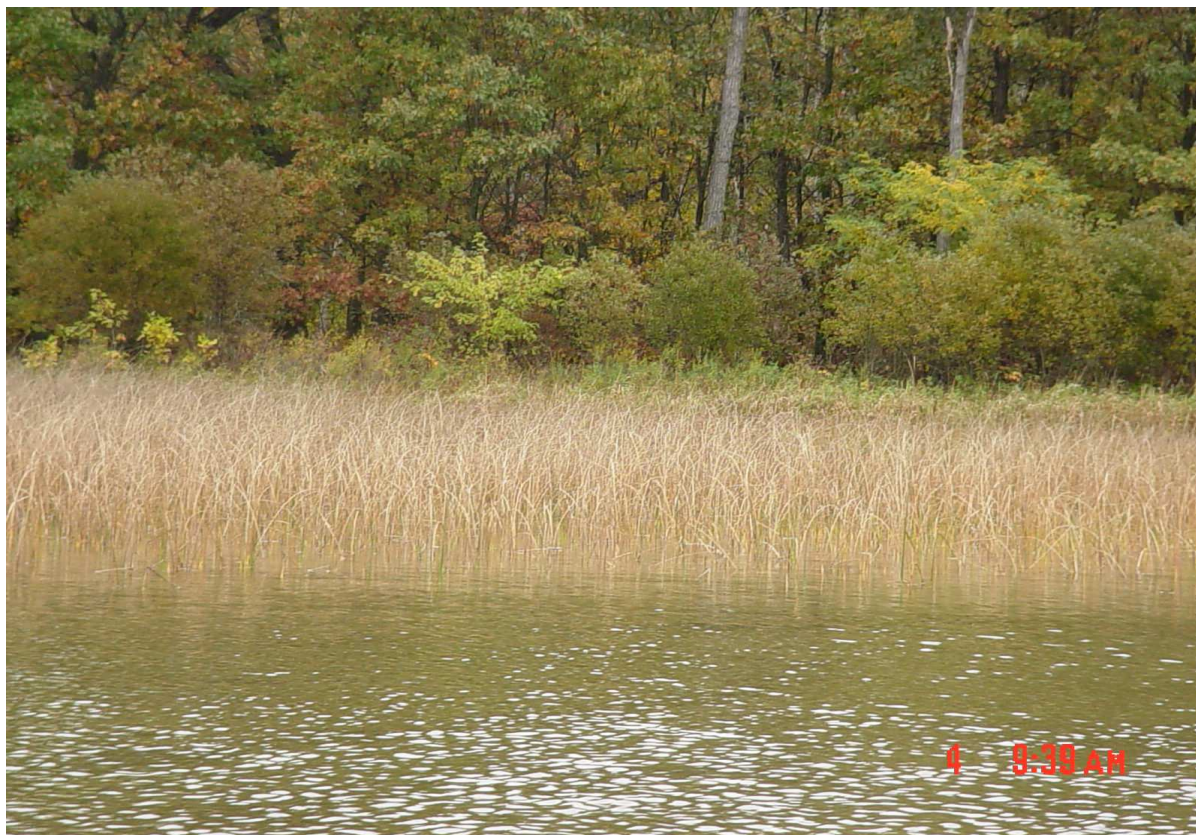
Figure 48: Photo of Area JO1, Jordan Lake

JO1 extends along approximately 2600 feet of the shoreline along the north side of the lake, extending up to the ordinary high water mark. 6% of the shore is wooded; 20% is native herbaceous cover. The balance of the shore is bare sand, cultivated lawn and hard structure. There is a shallow marsh area along this shoreline. Large woody cover is present for habitat. Maximum rooting depth of aquatic vegetation in JO1 was 19 feet. Seven types of emergent aquatic plants were found in this area. Emergents provide important fish habitat and spawning areas, as well as food and cover for wildlife. One free-floating and three floating-leaf rooted species were present here. Floating-leaf vegetation provides cover and dampens waves, protecting the shore. Eighteen emergent species of aquatic species were also found here. Such a diverse submergent community provides many benefits. Filamentous algae were present at this site, but not abundant.

One exotic invasive plant, *Myriophyllum spicatum*, was found in this area. Most of the aquatic vegetation in this area has multiple uses for fish and wildlife. This area of all three plant structures provides a lot of habitat diversity.

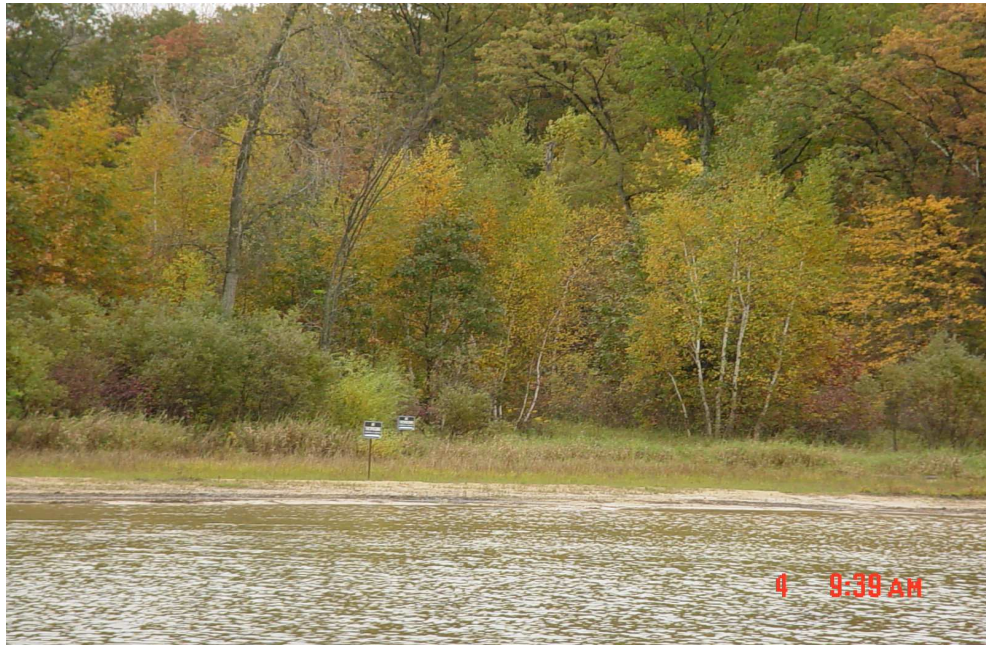
**Figure 50:
Part of Area
J02**

Most of these plants are used by wildlife and fish for multiple purposes. Because this site provides all three structural types of vegetation, the community has a diversity of structure and species that supports even more diversity of fish and wildlife.
